DECISION-MAKING FOR HISTORIC BUILDING DIAGNOSIS BY LOGICAL INFERENCE IN HBIM APPROACH: THE CASE OF ONSITE INSPECTION OF TIMBER ELEMENTS

Silvana Bruno, Mariella De Fino**

*Polytechnic University of Bari, Department of Civil, Environmental, Land, Building Engineering and Chemistry (DICATECh) – Bari, Italy.

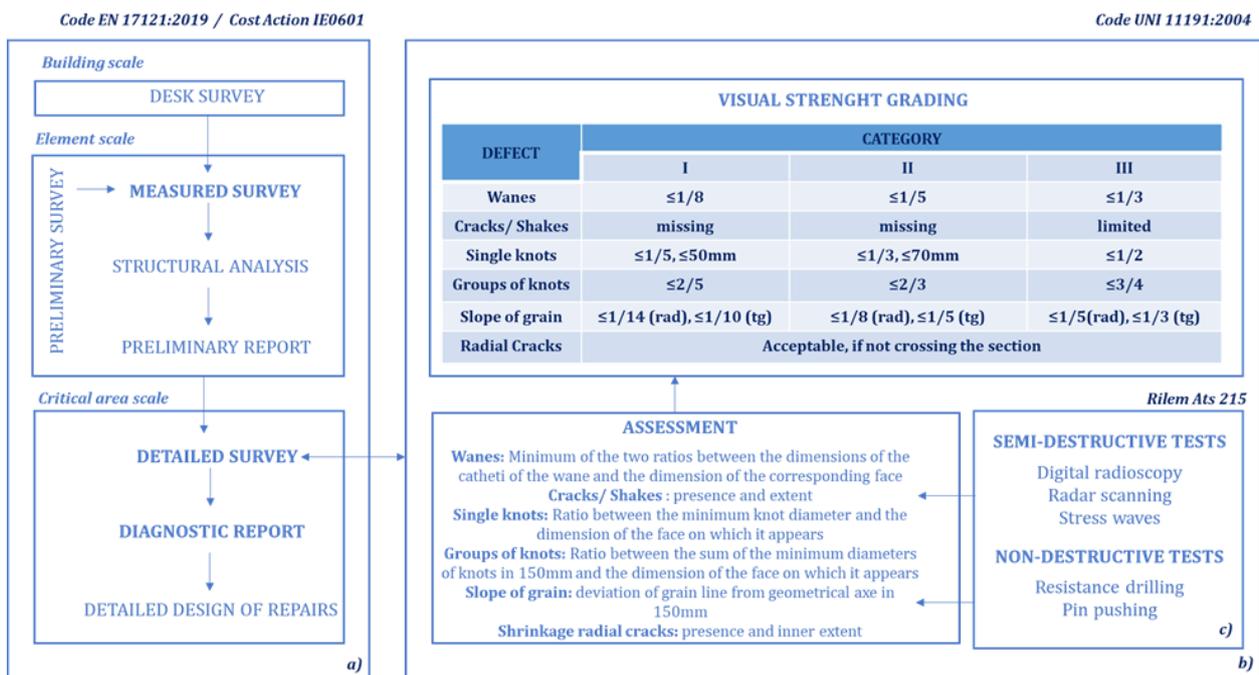
Fig. 1: General methodological framework from normative and scientific literature

The in situ inspection of structural timber elements is broadly debated at normative (Riggio, D'Ayala, Parisi & Tardini, 2018) and scientific levels, with specific focus on diagnostic techniques supporting the visual survey (Feio & Machado, 2015; Palma & Steiger, 2020; Sousa, Sørensen, Kirkegaard, Branco, Lourenço, 2013). In particular, the activities required for the strength grading are included in a comprehensive framework (Fig. 1a), as reported in the standard

Within this framework, the first phase concerns: "Desk Survey" based on bibliographic and archivist records on the design, realization and construction evolution over the time; "Preliminary Survey", providing with an overview of the structure that is sufficient to plan the next stage identifying what provisions need to be made to gain safe access to the site; "Measured Survey" leading to the description of the geometry, technical solutions and main alterations; "Structural Analysis" for the analytical assessment of the tension and deformation conditions; "Preliminary report", highlighting the aspects requiring further investigation and the recommended methods. Thus, the second phase involves: "Detailed survey" with exhaustive mapping of representative areas, namely critical zones, in terms of decay/anomalies/defects, also by means of diagnostic techniques; "Diagnostic report" where the results of the previous activity are displayed and discussed; "Detailed design of repairs", describing the most suitable treatments.

With specific reference to the in situ inspection for strength grading, the activities move from the "Measured Survey", in which the elements are described in terms of morphology (shape, dimensions, connections, ...), historical-cultural (frames, coatings, ...) and macroscopic pathological patterns (from inherent defects of the material, biological degradation and/or mechanical damage). Then, the same activities are specified in the "Detailed survey", where the analysis focuses on some representative areas, called Vulnerable Zones (VZs) for the determination of a resistance category based on visual and instrumental investigation. In particular, the latter sub-phase is thoroughly defined by the Italian standard UNI 1119:2004, which provides with an assessment method, where the resistance category (1, 2 or 3) results from some combined qualitative and quantitative analyses on typical defects, such as wanes, cracks/shakes, single knots, groups of knots, slope of grain, radial cracks of the selected VZs for each element (Fig. 1b). The category is, in turn, related to the mechanical strength, known the wood species. Consequently, methodical data collection,

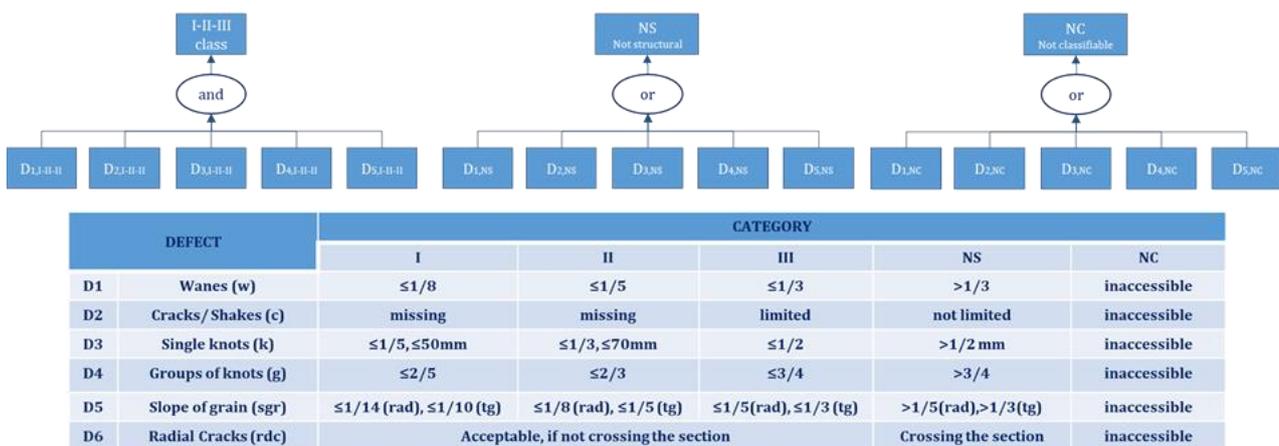
Fig. 2: Scheme of the inference logic for classification of VZs by VPL Dynamo

Once the values for each indicator have been filled in for each VZ – typically two per element -, the customized VPL script can process the information and assign to the element the lowest category calculated for the related VZs. In particular, the algorithm performs a classification on each of the identified VZ and element, according to the scheme in Fig. 2.

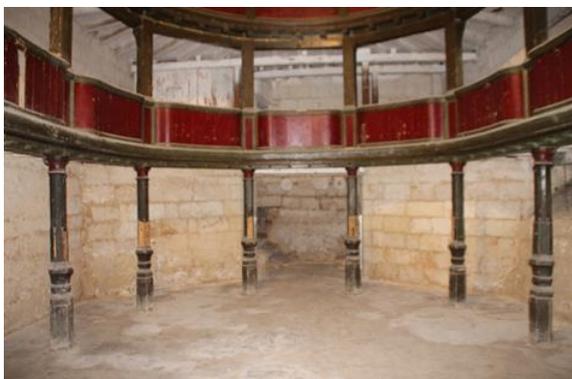
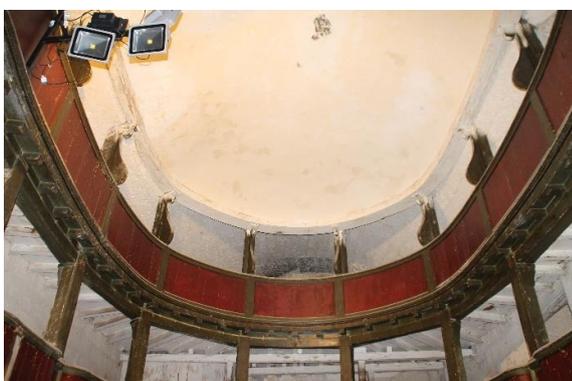
Fig. 3: Overview of the timber structures at the first level (above) and second level (below) of the theatre

The theatre (Fig. 3) is composed of two sections above the stage level. The first level was dedicated to the noble families, while the second one hosted common people. The floorings are supported by ten columns and nine beams for each level. Moreover, considering the additional timber decks connecting the audience sections with the stage and the columns bearing the roof, the theatre counts thirty-four columns and twenty-two beams.

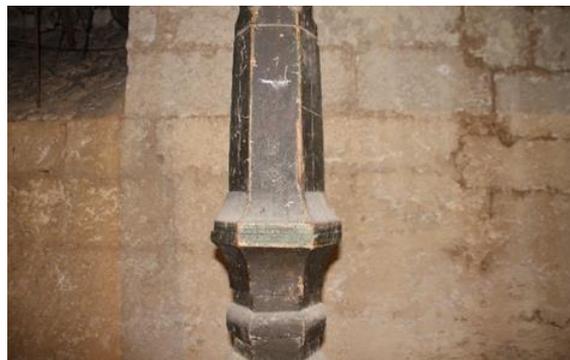
Fig. 4: Detail of the pillar at the first level

Concerning the typological and architectural characteristics, the columns at the first floor show hexagonal shape, with variable sections between 0,00m and 1,20m and dodecagonal shape above 1,2m (Fig. 4), while the columns at the second floor have rectangular shape with waners of different extent.

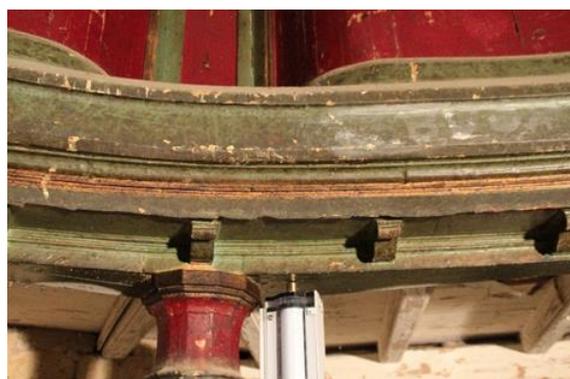
Fig. 5: Detail of the pillar at the first level

The beams at the first and second floors are composed of two juxtaposed elements, the inner with constant square shape, the outer with variable rectangular shape, resulting in a curved profile toward the stage. All the elements are enriched by decorations with red, green and gold pictorial layers: such layers are applied on cladding boards at the first level and directly on the elements at the upper levels (Fig. 5).

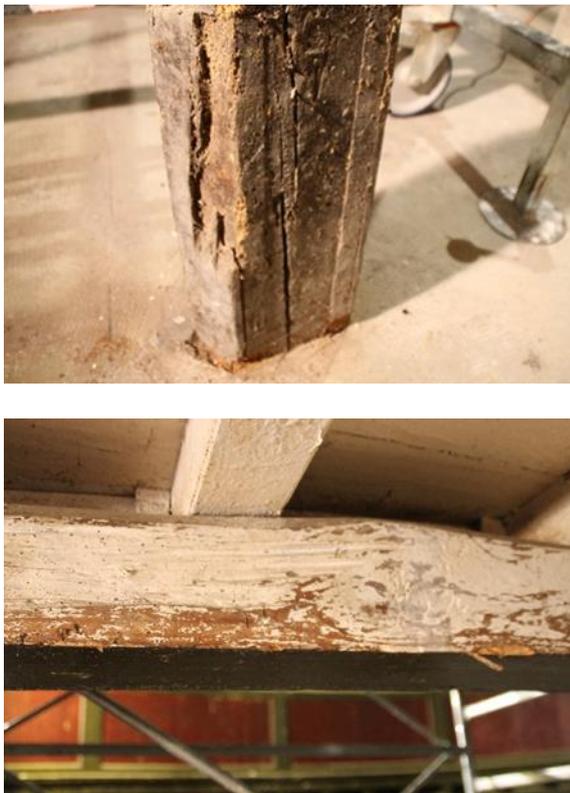
Fig. 6 Example of decay on the pillars (above) and on the beams (below) at the second level

As far as the state of conservation is concerned, it should be mentioned that all the elements show a general physical obsolescence, worsened by the conditions of abandonment over the last decades, with evidence of cracks, missing parts and surface alterations, particularly at the second level (Fig. 6). All the elements were investigated in order to assess their resistance category, as detailed in the

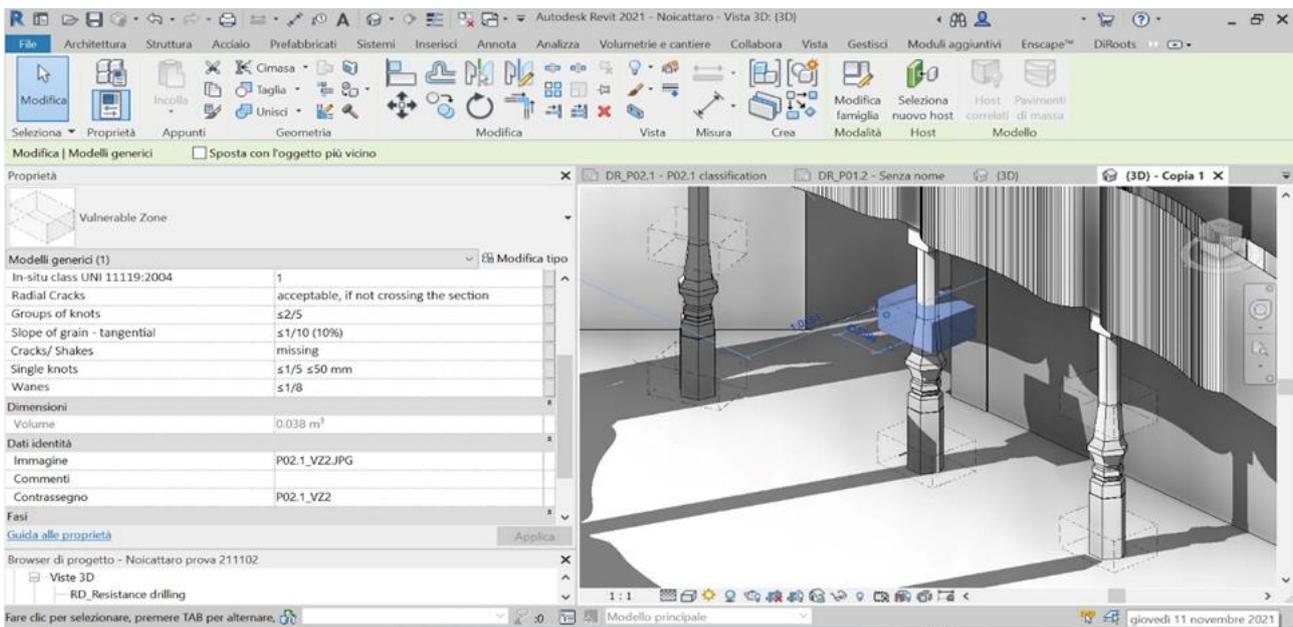
Fig. 7: BIM modelling of the Vulnerable Zone and related parameters' visualization

The values have been exactly reported with respect to the selected coding, so that they could be used by the inferential algorithm (Fig. 7).

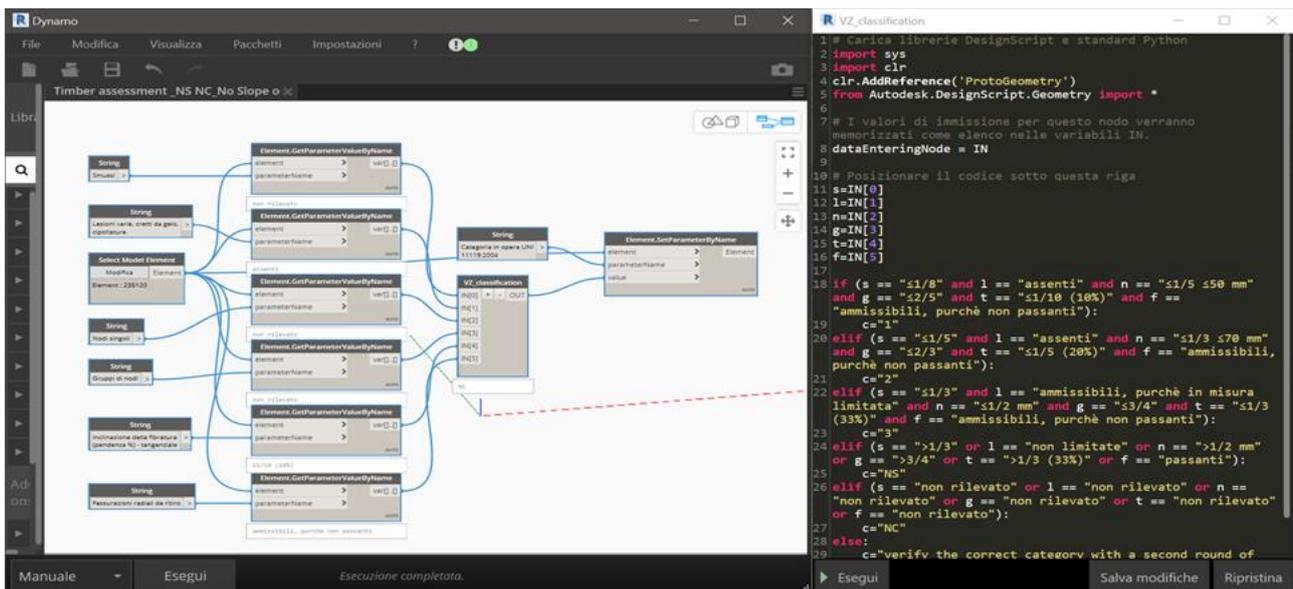
Fig. 8: Classification of the Vulnerable Zone in VPL Dynamo

The definition in VPL started from the selection of the "Vulnerable zone" BIM object from which the parameters and related values have been filtered for the characterization. The inference algorithm compared the indicators 'values with the previously defined rules for classification developed into a custom Dynamo node written in Python (Fig. 8):

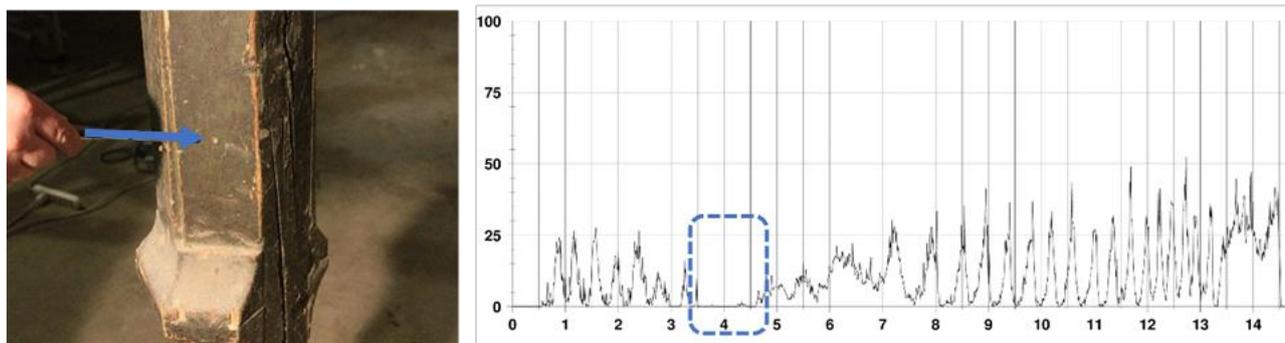
Fig. 9: Resistograph test showing a density decrease corresponding to radial cracks on the adjacent sides

The resistograph tests were performed by IML-RESI F400-S resistograph. They made it possible to measure the resistance of the material to the penetration of a metal tip with a millimetre diameter along a cross section and, therefore, to locate any density reductions, corresponding to the presence of inner cracks (Fig. 9).

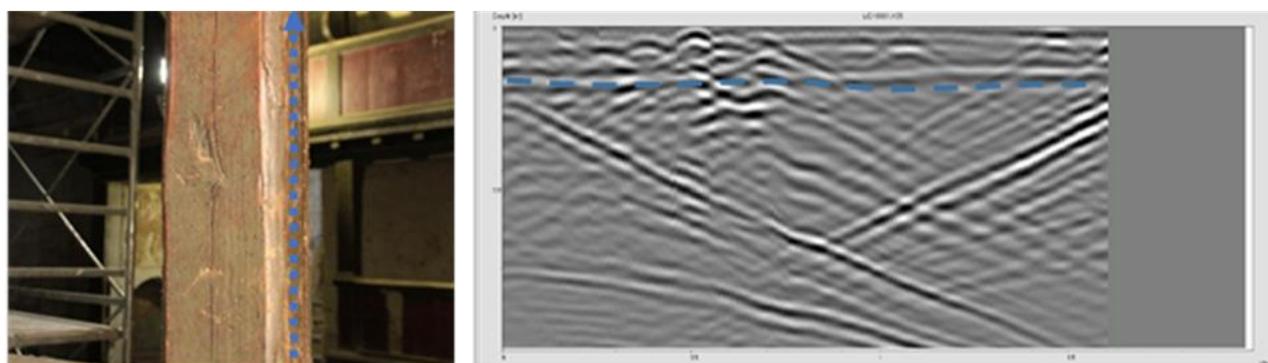
Fig. 10: Radar scan showing a continuous plane of discontinuity corresponding to radial cracks on the adjacent sides.

The radar scans were acquired by IDS DAD Fastwave and TRHF 2000 antenna. They allowed to evaluate the behaviour of the timber elements with respect to the transmission/reflection of high

frequency electromagnetic waves, on the basis of which it was possible to identify or exclude internal cracking planes (Fig. 10). It should be noted that, as additional decision support tools, the HBIM model template contains information sheets for the application and assessment of the diagnostic tests, including the link to the online available database that collects the above-mentioned best practices of previous case studies, organized by type of test and result (Fig. 11).

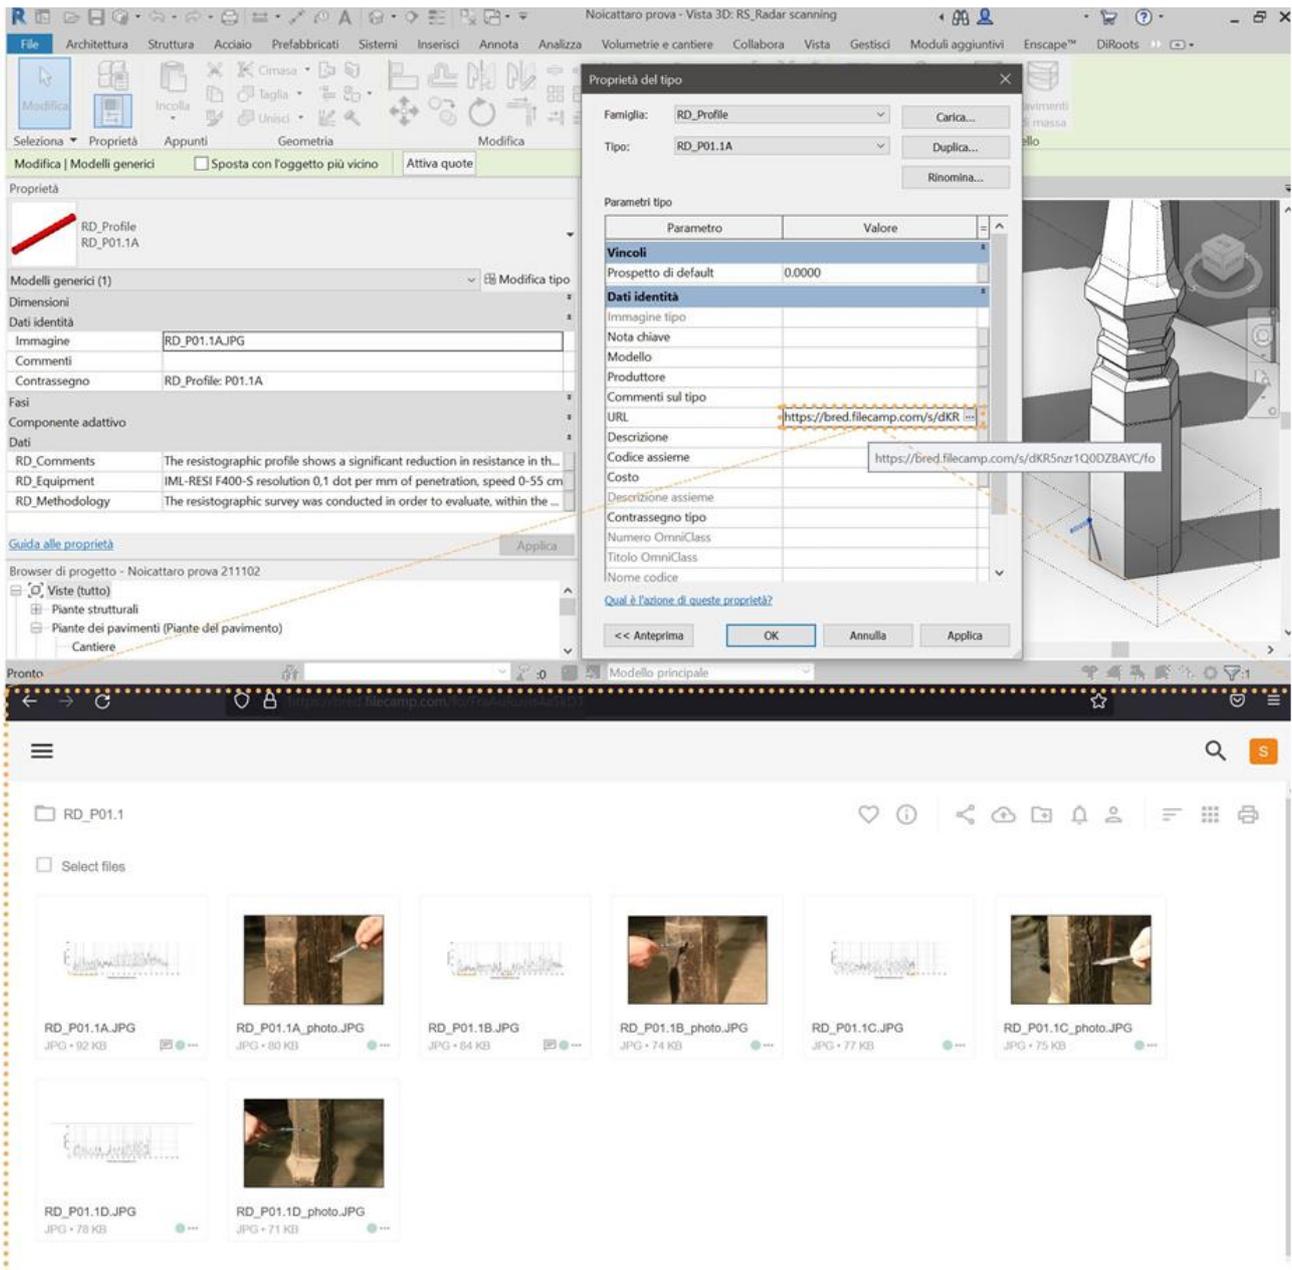
Fig. 11: BIM modelling of the NDT Profile and availability of a link to a web-based database of previous case studies

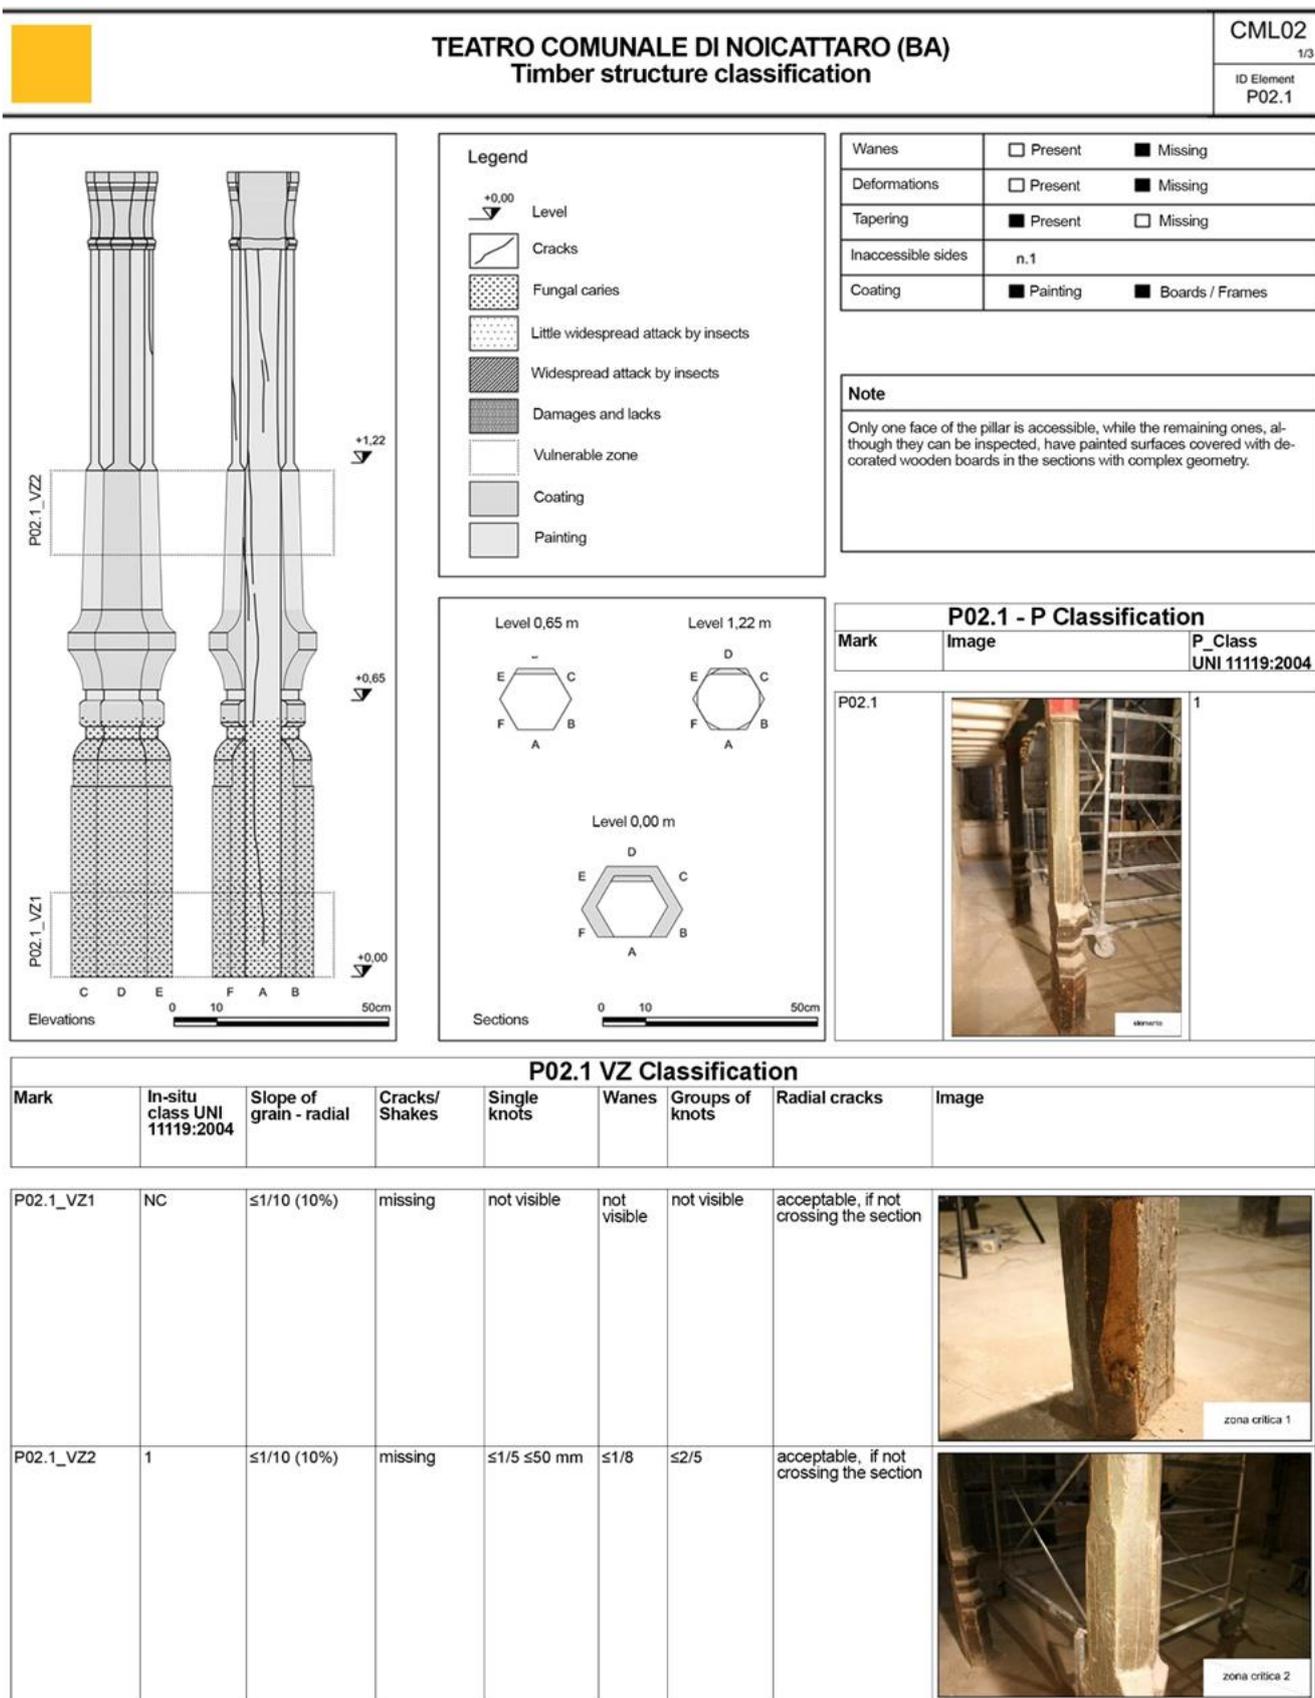
Fig. 13: Report for VZ and column classification and decay mapping

Based on what the standard EN 17121:2019 indicates, the “Diagnostic report” collected the observations of the entire set of investigations carried out on the VZs and on the structural elements to provide comprehensive analysis sheets. In the proposed framework, the reports were drawn up for each structural element, columns and beams, depicting the decay mapping on the elevation of each element with lines and detailed filled regions, including the automatic synoptical legend, as well as the geometric variability of the section in the columns, the height at which this variation occurs and the cladding portions.

In addition, a table has been inserted to summarize the characteristics of the element and a box with notes. In the same report, the tables deriving from the Revit schedules have been prepared to describe the identified vulnerable zones and the elements with the relative resistance classes, automatically assessed; photographs and the observations (Fig. 12).
