THEORETICAL RECONSTRUCTION OF THE 5TH CENTURY COMPOSITION OF THE TEMPLE OF TEKOR

Abstract

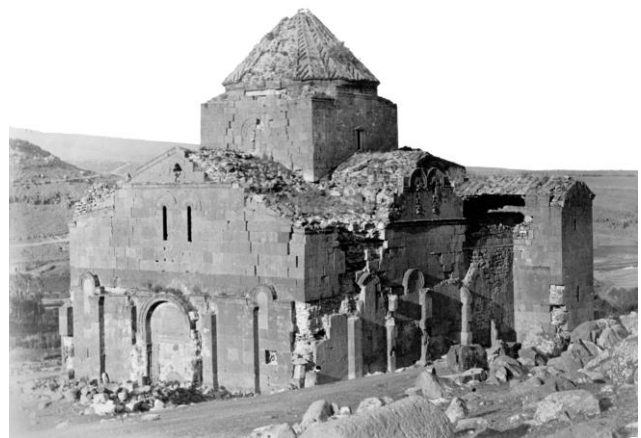
Fig. 1: Archive photo of the Tekor temple, view from the southwest. Photo Credit: RAA Archives

The study of Tekor Temple (Fig. 1) can be conditionally divided into two stages: before 1920 and after. This is due to the deterioration and collapse of the monument in the period 1912-1920. In fact, the older generation of researchers had the opportunity to measure, photograph and study it on site.

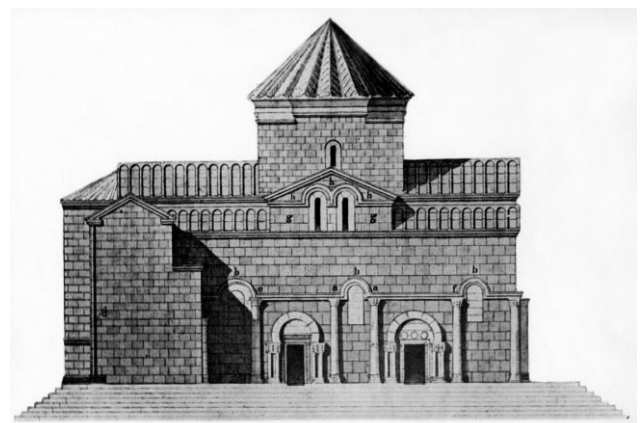
Fig. 2: Theoretical reconstruction of the Tekor temple, according to Toramanyan

reconstruction of the monument based on archival materials - floor plans (Fig. 3), sections, measurements of the facades, as well as the theoretical reconstruction carried out by T. Toramanyan (Fig. 2), etc. For certain facades, archival photos were also used, which were brought to the frontal position and scale using specialized computer programs. Taking into account the fact that the temple has undergone numerous reconstructions over the centuries, stratification was also carried out. The views of researchers regarding the origin of the monument differ sharply and in some cases even contradict each other. According to some scientists, the temple had different construction phases. Built as a three-nave basilica, it was later rebuilt as a domed three-nave basilica. However, this view was refuted by some researchers. Contradictions also refer to some reconstructed parts of the monument. Considering all possible versions and

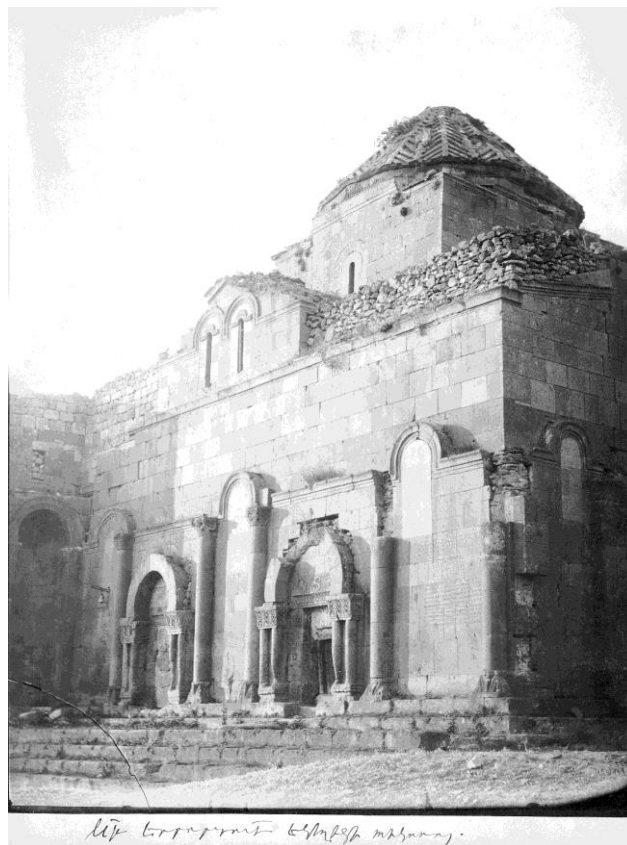
Fig. 5: Archive photo of Tekor temple, view from the northwest. Photo Credit: RAA Archives

Archival photos (Fig. 4-5) clearly show that the stonework in the galleries, the altar on the eastern facade, the colonnade are uniform and there are no traces of any reconstructions or additions. The destroyed sections of the walls indicate that the outer stone layer of the midis masonry is structurally uniform with the layer of lime concrete.

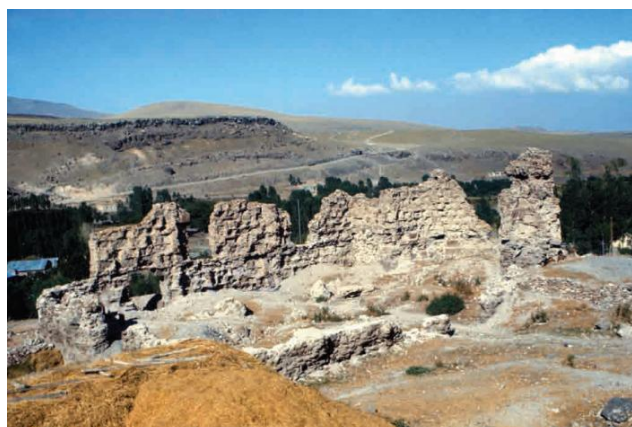
Fig. 6: The current appearance of the ruins of the temple of Tekor

earliest examples. However, as previously mentioned, the monument is now completely destroyed, with its fragments missing on-site (Fig. 6). Therefore, the Tekor temple is not subject to restoration. In this case, a virtual reconstruction becomes particularly significant.

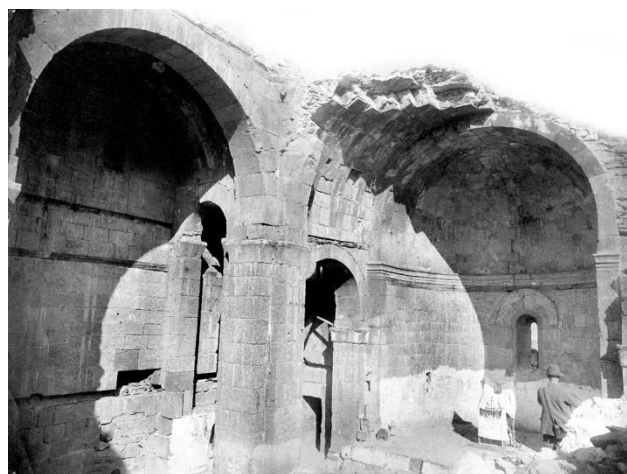
Fig. 7: The interior of the Tekor temple after its demolition.
Photo Credit: RAA Archives

In the Tekor temple, the walls inside, have anti-seismic belts at different levels, which are made of wooden boards (Fig. 7). Such belts are also present on all longitudinal arches, at the base of the altar conch, and within the sub-dome square. The use of wooden boards in the construction of the walls not only creates connections in the horizontal direction, but also the load falling from the upper rows of the walls is distributed more evenly both on the rows of masonry walls and on the arches. Such measures of strength and seismic resistance can explain the fact that the temple has stood for fifteen centuries.

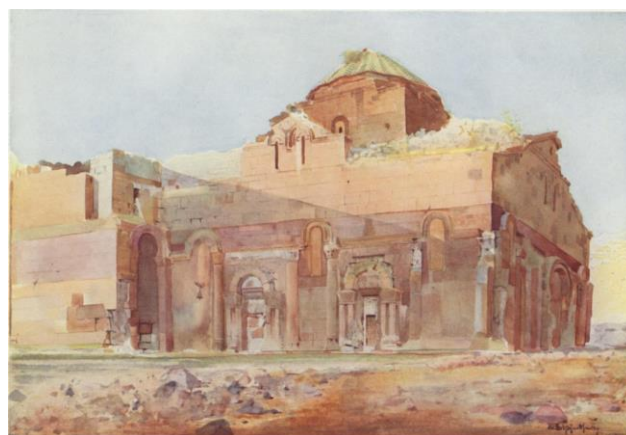
Fig. 13: Watercolor of Tekor temple by Arshak Fetvadjan, 1906

The archival photos of the Tekor Cathedral are black and white, so we get an idea of the color and tone of the stone facing the walls of the church mainly from the watercolor painting of Arshak Fetvadjan from 1906 (Չոբադյան, Գ., 2001, p. 59), (Fig. 13), as well as the written descriptions of Nikoghayos Mar. He writes: "The stone is of two types, both are most likely tuff, one is pinkish in color, it is close in color to the Yereruyk, but there can be no doubt about its identity, the other with

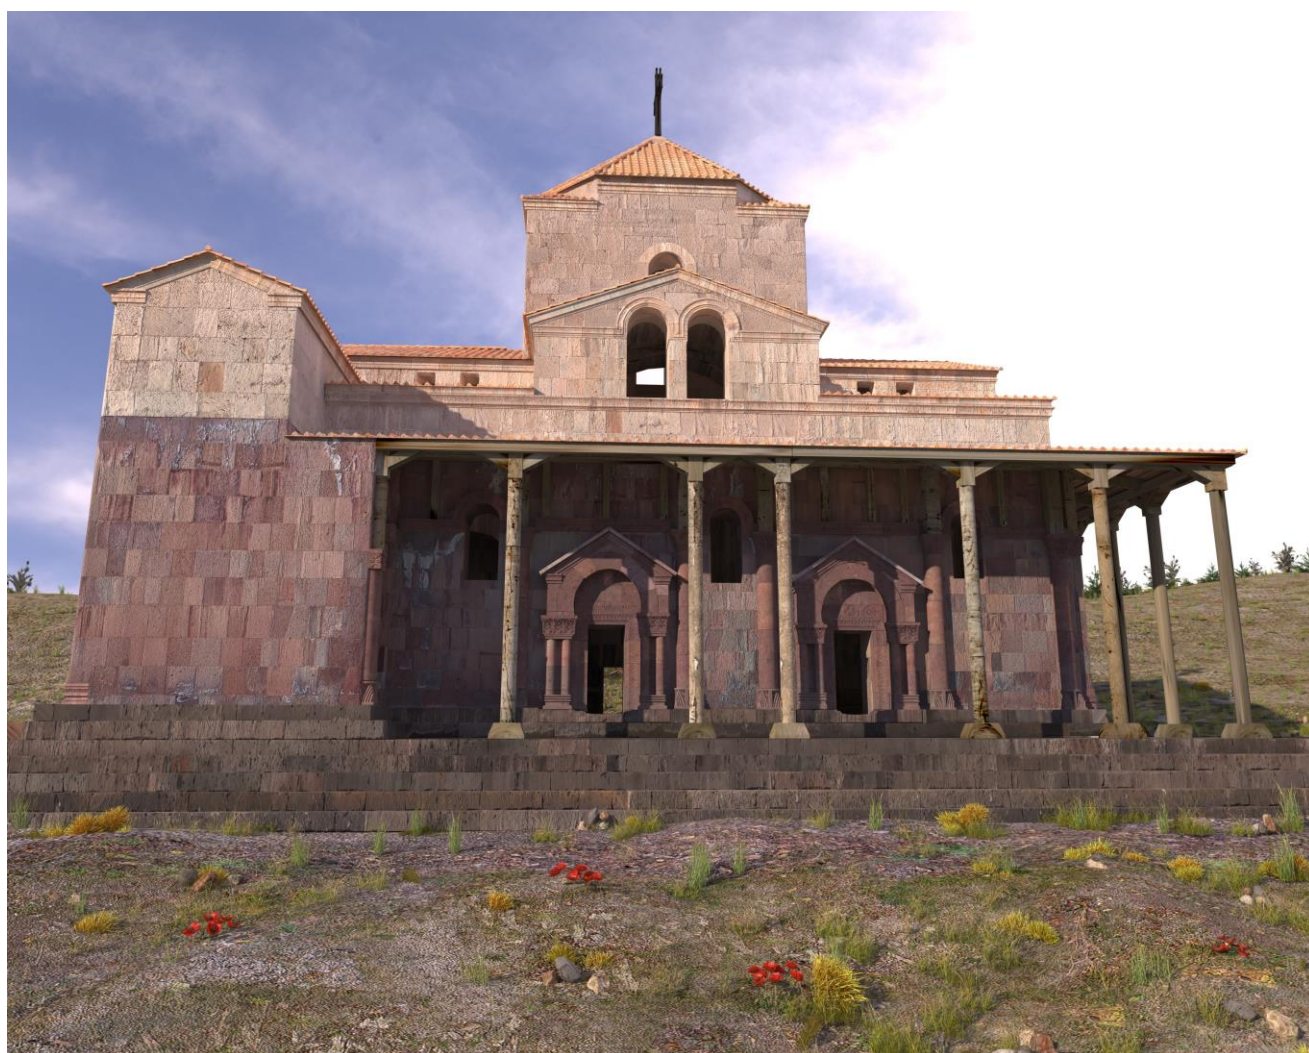
Fig. 18: The north facade of the Tekor temple, theoretical three-dimensional reconstruction carried out by the author

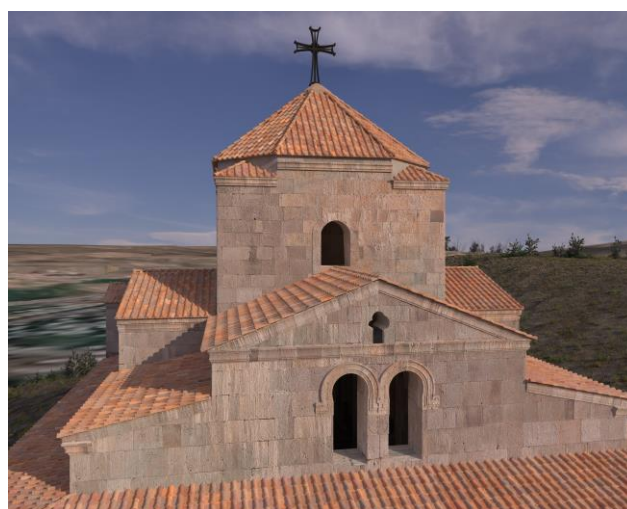
Fig. 20: The west facade of the Tekor temple and the roof tiling

limestone concrete would have remained on the walls, at least one to one and a half rows high, and this is clearly visible in the photos, that such traces are absent. In the Yereruyk temple, the halls had arches extending in the longitudinal direction, traces of which have been preserved in the form of a stone ledge on the wall of the south-eastern sacristy. There are no traces of longitudinal arches in the Tekor temple either. Therefore, it should be concluded that the roof of the halls, as well as the supporting columns, were entirely wooden (Fig. 21-23). We took the lowest point of the gallery roof as the minimum mark of the roof of the north-eastern altar (Fig. 21), and the highest point should not be higher than the lower part of the pair of windows on the western facade (Fig. 20).

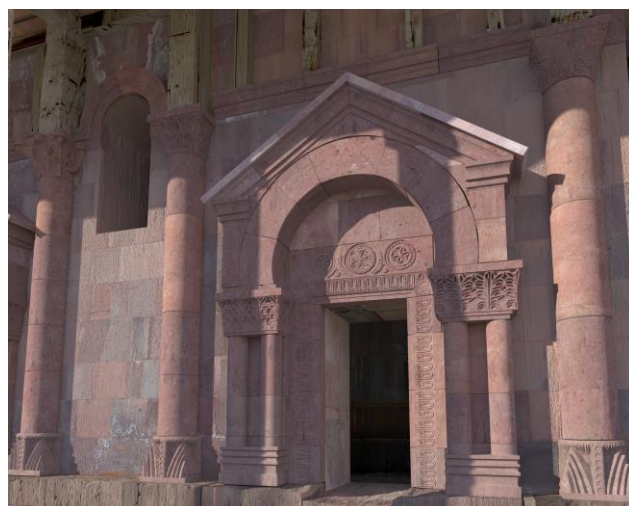
Fig. 24: The northwest entrance to the Tekor temple

The portals of the temple are reconstructed according to the traces of limestone concrete on the walls, as well as by analogies with the portals of the Yereruyk temple, with arches and gable pediments placed on pillars protruding from the plane of the wall (Fig. 24-27).

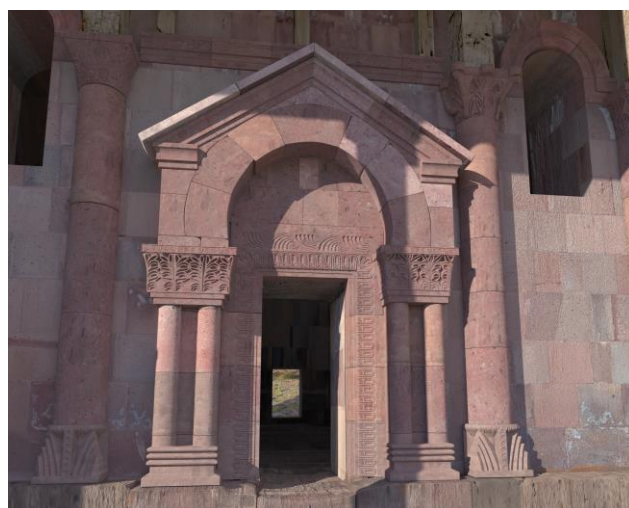
Fig. 25: The northeast entrance of the Tekor temple

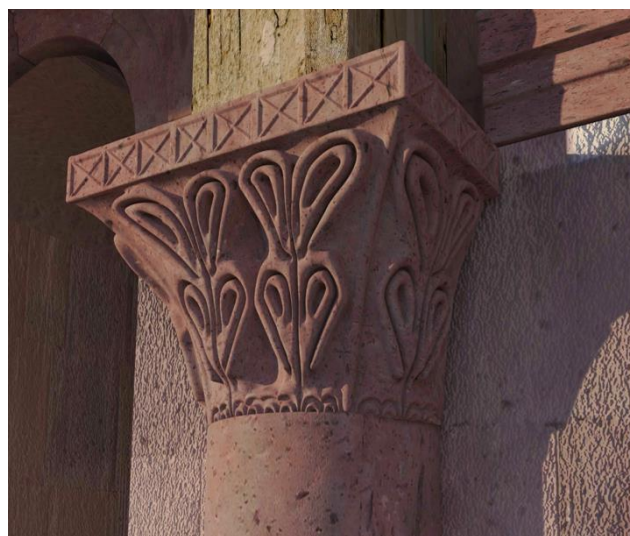
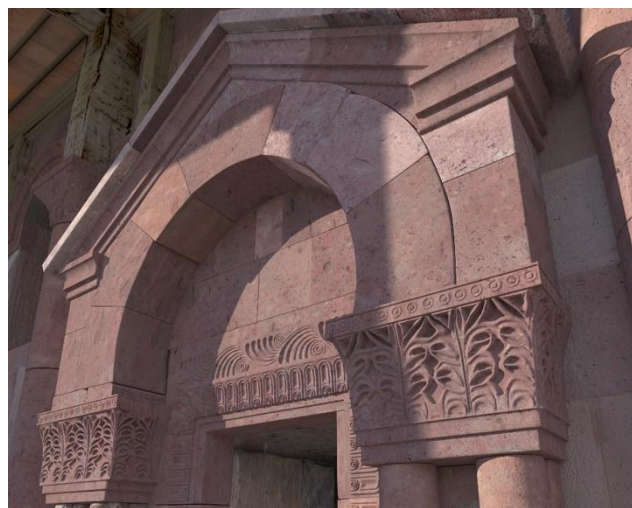
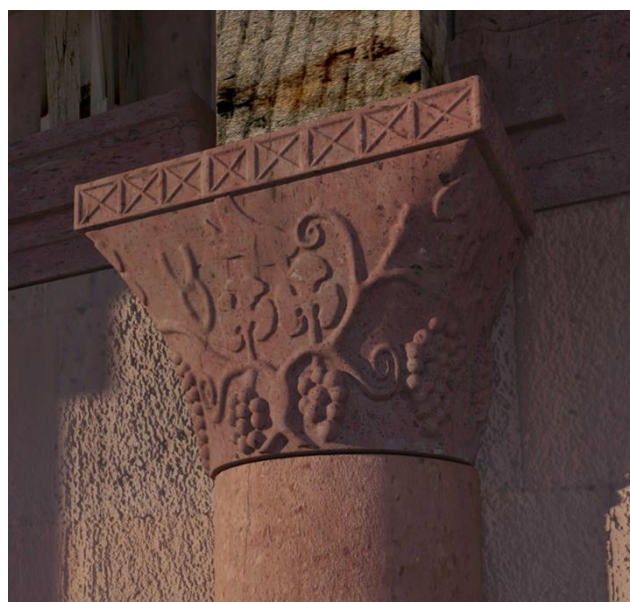
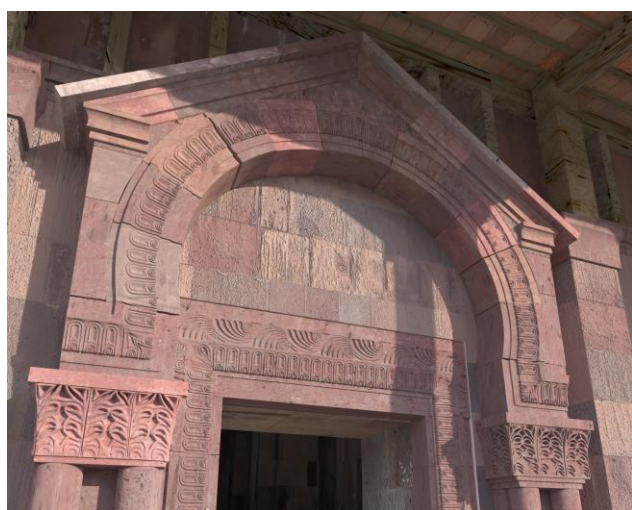
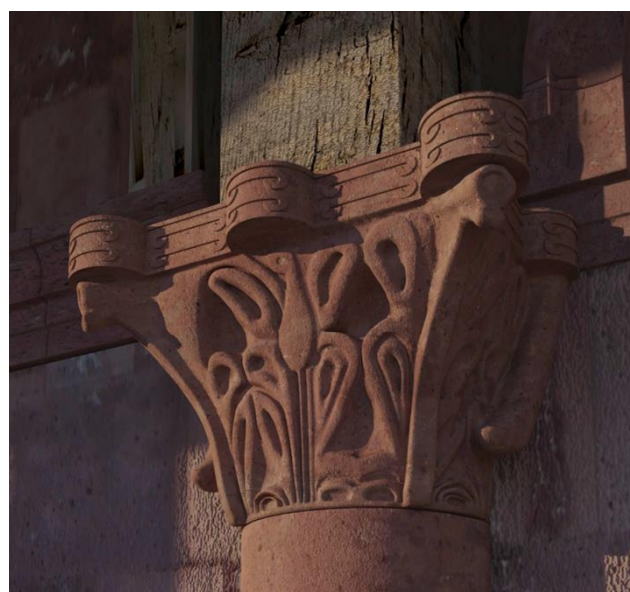
Fig. 27: Details and capitals of the Tekor Temple
