# H-BIM FOR THE CONSERVATION OF WOODEN STRUCTURES: A KNOWLEDGE-BASED PROTOCOL INTEGRATING GEOMETRY, HISTORY AND STRUCTURE

*Maria Parente\*, Federica Ottoni\*\**

\*Dipartimento di Scienze dell'Antichità, Sapienza Università di Roma – Roma, Italy; Dipartimento di Ingegneria e Architettura  
Università di Parma – Parma, Italy

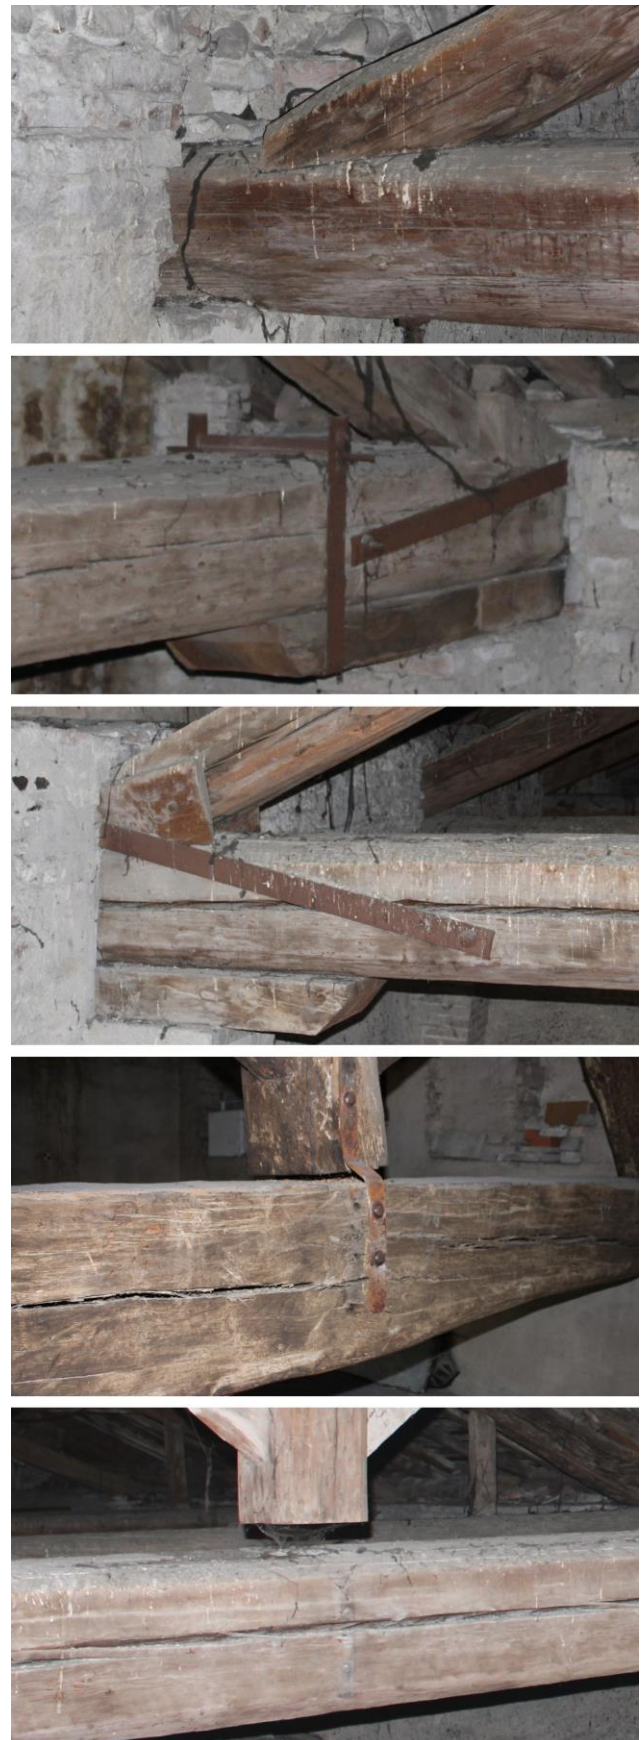
**Fig. 2:** Examples of different kinds of connections between rafters and tie-beam of trusses and different configurations of king post.

The next group pertains to the “Construction Details”, which include both the embedding of the beam into the masonry and the connections between different wooden structural elements (Fig. 2).

Construction details can be simplified in the geometric model, yet transposing the fundamental data as associated information. As well known, the type of connection is particularly important, as it influences the structural constraint to be applied in the structural modeling process. The description of constraint is suggested and then

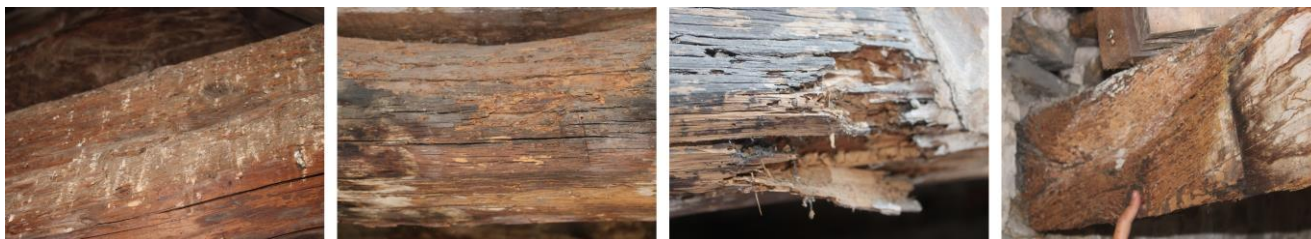
Fig. 4: Different levels of severity of decay. From left to right: level 1-2, level 3, level 4-5, decay limited to beam head.

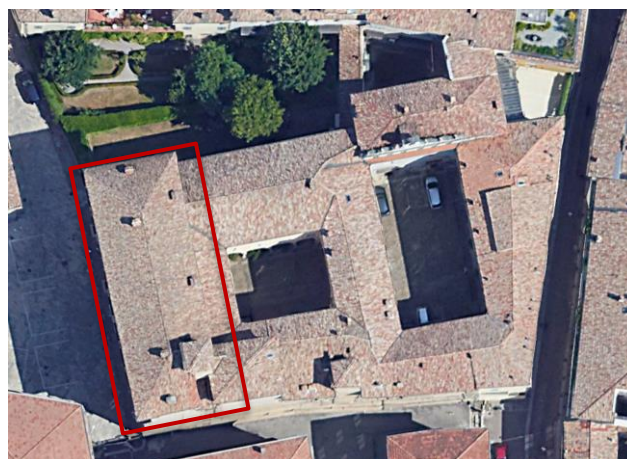
Palazzo Pallavicino (Fig. 5) located in the historic center of Parma (Italy), proved to be a highly interesting case study for testing the

Fig. 5: Aerial view of the building with identification of the portion for which the H-BIM model was developed.

The portion of the building investigated in this study is the result of the 18<sup>th</sup>-century transformations, which included the façade, vaults at various levels and, consequently, the roof. Therefore, it is likely that the oldest wooden elements of the roof, such as the trusses, date back to these interventions. The roof consists of four “Palladian” type trusses (Fig. 7), featuring a king post and diagonal braces. Some of these trusses include props that reduce the clear span to limit the bending of the rafters. In addition, several solutions for bearing on the wall can be observed.

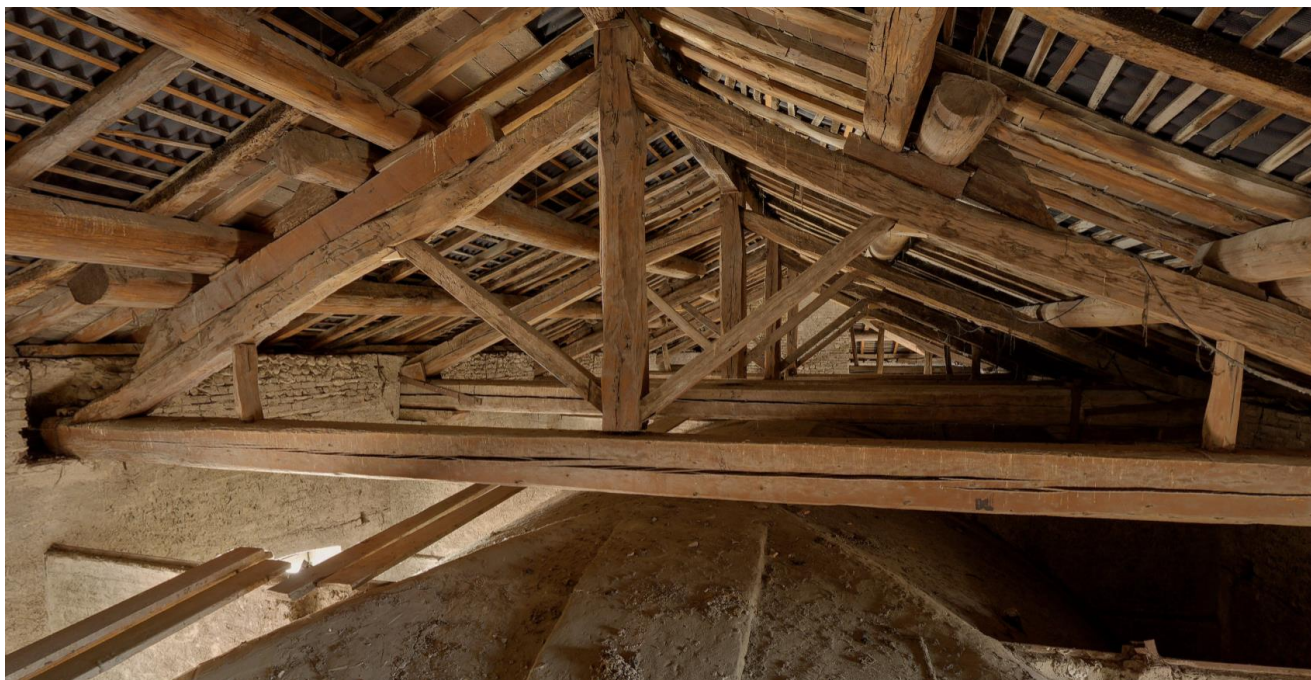
Fig. 6: Photo of the portion of roof of which the H-BIM model was developed.

This part of the roof has undergone several restoration works, including the replacement of most purlins and joists, as well as the partial modification of the upper stratigraphy. This latter was likely originally composed of wooden battens, with terracotta tiles placed only over the trusses to ensure better waterproofing. Below the examined
