THE UNFINISHED PROJECT OF THE CHURCH OF IZNALLOZ: ORIGINS, BUILDING PROCESS, AND GRAPHIC RECONSTRUCTION PROPOSAL

Abstract

The findings are twofold: first, a construction sequence that identifies the specific changes made to the main facade over time; and second, a reasoned graphic reconstruction of the temple based on elements attributable to Siloé and his prior architectural experiences.

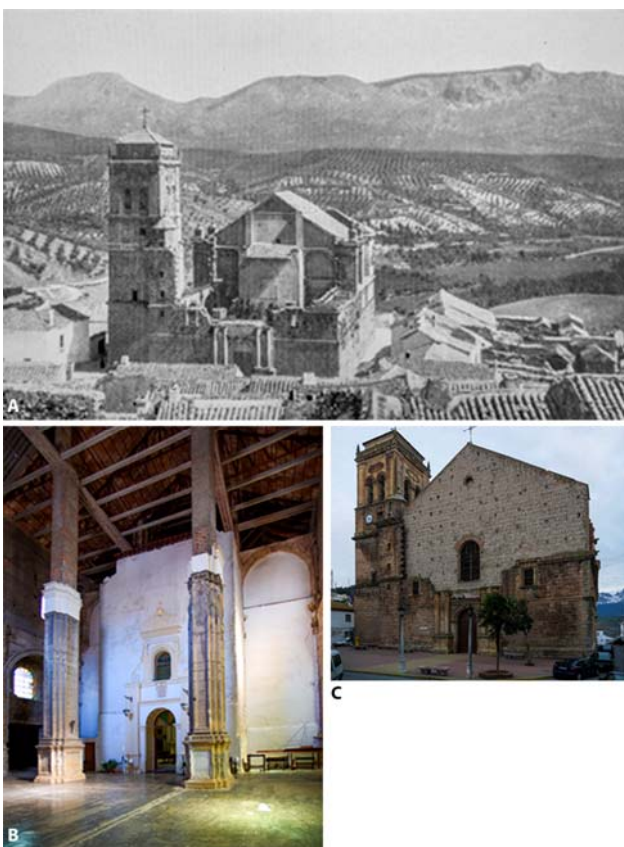
Fig. 2: Entrance section: (a) Early 20th-century photograph by A. Martín (1910), (b) current interior, and (c) current main facade; author's own photographs.

Between the completed and the unfinished sections, a temporary masonry partition was erected in the 16th century to allow religious activity to continue within the parish while construction work proceeded (Figures 2 and 3). These efforts were abandoned in the 17th century for economic reasons following several changes in master builders, leaving half of the nave space uncovered until the last century (Figure 2a). It was then decided to close this section by completing the facade with concrete blocks and installing a roof supported by metal trusses (Figures 2b and 2c).

We have no news regarding the construction of the church until well into the 20th century. Little or nothing had been done in the parish until this point: between 1780 and 1783, we have records of some designs being made to finish the work (Llaguno and Ceán-Bermúdez, 1977; Gómez-Moreno Calera, 1989), though we do not know their content or if anything was actually executed. This is attested by the description of the church made by the Gómez-Morenos during their visit in 1886 and by some historical photographs we have been able to collect (Figures 2a, 7, and 8a).

In the 1960s and 1970s, major changes took place that altered the structure and image of the church: the steps of the high altar were extended into the nave (Robles 1998), the current block wall was erected on the facade, and the space at the foot of the church was enclosed with a metal roof (Figures 2b, 2c and 5). Furthermore, the additions to the south facade were demolished for the declaration as a historical-artistic monument, granted in 1973 (Ministerio de Educación y Ciencia, 1973).

On the other hand, we know that there were three doors in this partition wall: the main one on the church's axis and two others, which are now bricked up (Rodríguez, 2023). Above the central door, there is a window (Figure 2b) whose moldings match those of the high windows in the completed section.

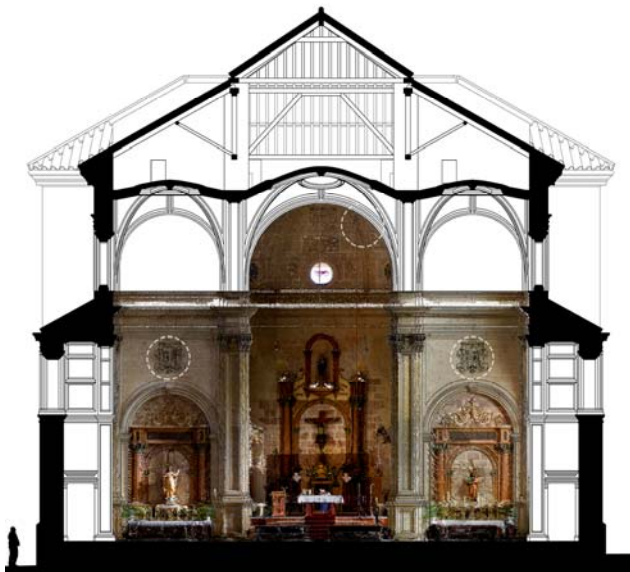
Fig. 4: Transverse section with the triumphal front highlighted, marking the cartouche dated 1558 and the coats of arms of Archbishop Pedro Guerrero. Own elaboration.

1. In the vault of the main chapel, there are three large cartouches that together read "ANO DE IHS NAZ 1558" (Figure 4). This could indicate the completion date of this sector which, along with the large coats of arms of Pedro Guerrero on both sides of the chancel arch, seem to form part of a celebratory message intended to be visible from the aisles.

The study of the architectural order that structures the church's space also provides data regarding the original project. The pillars are cruciform, and their faces correspond to the space they open onto. For example, the isolated pillars have a principal order on all four faces that supports the transverse ribs of the vaults. In contrast, the pillars on either side of the chancel arch have only two faces where the principal order is developed, while the wall pillars present this order on only one face (Figure 4).

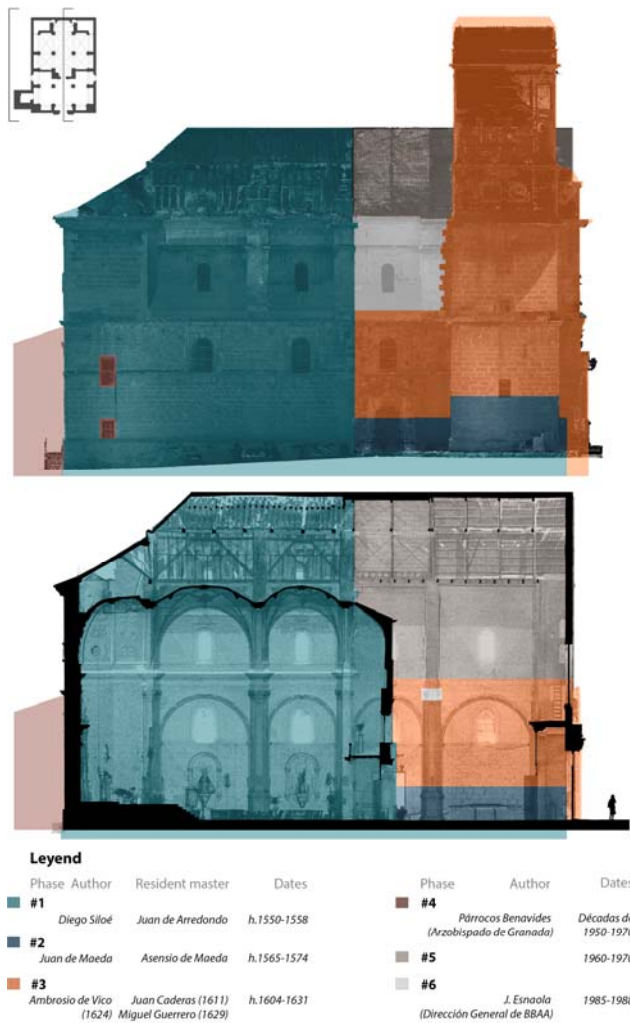
Fig. 5: Construction stages and chronology. Own elaboration.

The alignment of all these disparate yet convergent data leads us to assume that the first construction stage took place between 1549 and 1558, and that it encompassed the execution of all the foundations, along with the completion of the chancel and the first two bays of the aisles (Figure 5).

Two to three *varas castellanas* are equivalent to 1.67–2.50 meters in height (Figure 5); that is to say, very little progress was made at the foot of the church during this construction phase, the state of which at that time is reconstructed in Figure 6.

At this point, the works would have reached the height of the first cornice level, about ten meters (Figure 5).

The final changes occurred during the fifth construction period, from 1985 onwards, with specific interventions: for example, the current resin capitals were made and the stone cladding next to the tower was erected (Figure 5). Furthermore, the replacement of the block wall and a new roof—intended to evoke the vaulted structure of the completed section—were planned, but never came to fruition (Acosta, 2022b).

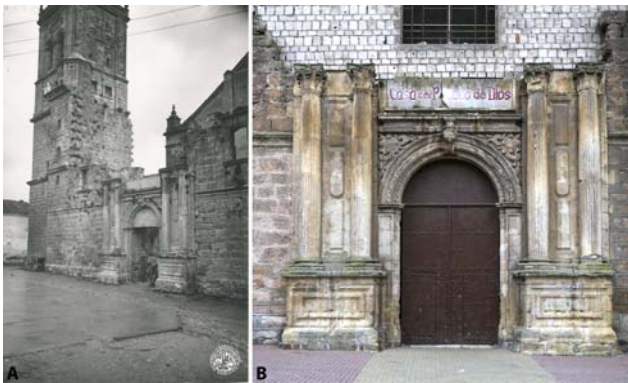
Fig. 8: Main portal: (a) 1939 photograph. Instituto Gómez-Moreno. (b) Current photograph. Author's own photograph.

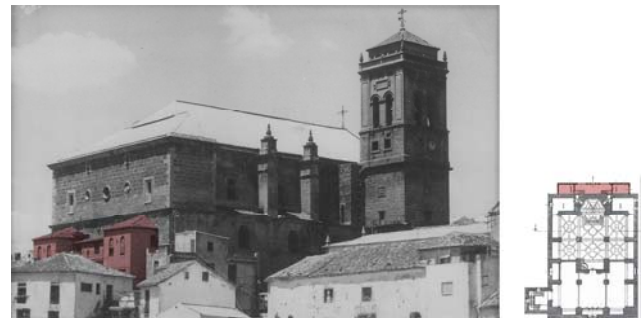
Fig. 9: Volume attached to the south facade: (a) photograph circa 1950 by an unknown author and (b) floor plan drawn around 1970 (Robles, 1998). Red highlighting is the author's own.

The fourth period once again brought about a major change to Siloé's project. In the 1950s, the parish priests, the Benavides brothers, attached a multi-story dwelling to the south facade (Figure 9). To connect this volume with the church, they opened new openings on the ground floor and converted the windows into doors, blurring the original elevation.

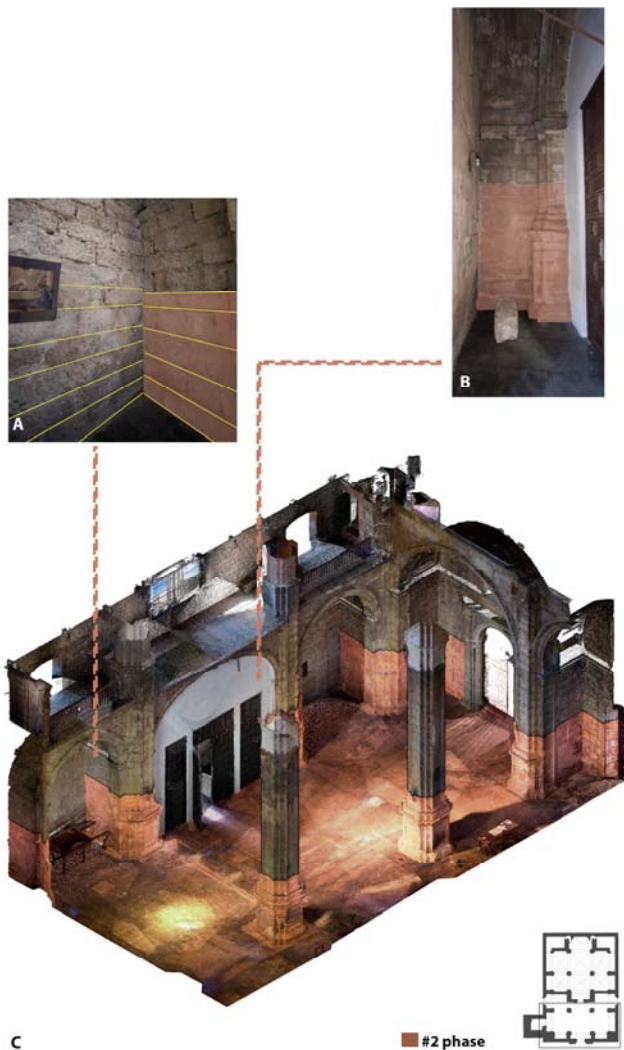
Fig. 10: Foot of the church: (a) lack of bonding between the buttresses and the facade wall; (b) distorted order; (c) perspective view highlighting the 16th-century construction. Author's own.

A masonry study reveals that the first courses of the walls dividing the chapels at the foot of the church are bonded with the pillars of line 6, but not with the facade wall (Figure 10a). From the seventh course onwards, the fabric is linked. These disconnected courses coincide with what was built up to 1591—between two and three *varas*—and

is, the principal order is developed between supports 6C and 6D, while the smallest order is developed between 6D and 6E (and its symmetrical counterparts 6B and 6C) (Figure 11b). The springing of these pillars reveals that in the central section of the foot of the church, Siloé had planned a principal order reaching the height of the cornice, which De Vico interrupted with a basket-handle arch and a distorted shaft (Figure 10b). On either side, two smaller openings appear, which today also do not correspond to the original syntax (Figure 10c).

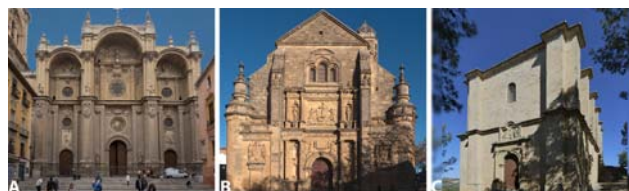
Fig. 14: Diego Siloé: (a) Granada Cathedral, (b) Sacra Capilla de El Salvador in Úbeda, and (c) La Villa in Montefrío. Author's own photographs.

Other religious buildings by Siloé also feature supports on their facades which, in turn, form part of an image integrated into the urban fabric. Such is the case with: Granada Cathedral (1528), the Sacra Capilla de El Salvador in Úbeda (1536), and the small church of La Villa in Montefrío (1549) (Figure 14). On the exteriors of these examples, the wall surface is composed of secondary orders that frame portals, windows, and decorative motifs, creating a facade that engages in a dialogue with its immediate surroundings. In contrast, Ambrosio
